## Supplemental Phase II Environmental Site Assesment Report

### State Center Property – Parcel I2

101 West Preston Street  
Baltimore, Maryland 21201

**REPORT: GEOPHYSICAL INVESTIGATION**  
State Center Property Parcels  
Baltimore, MD

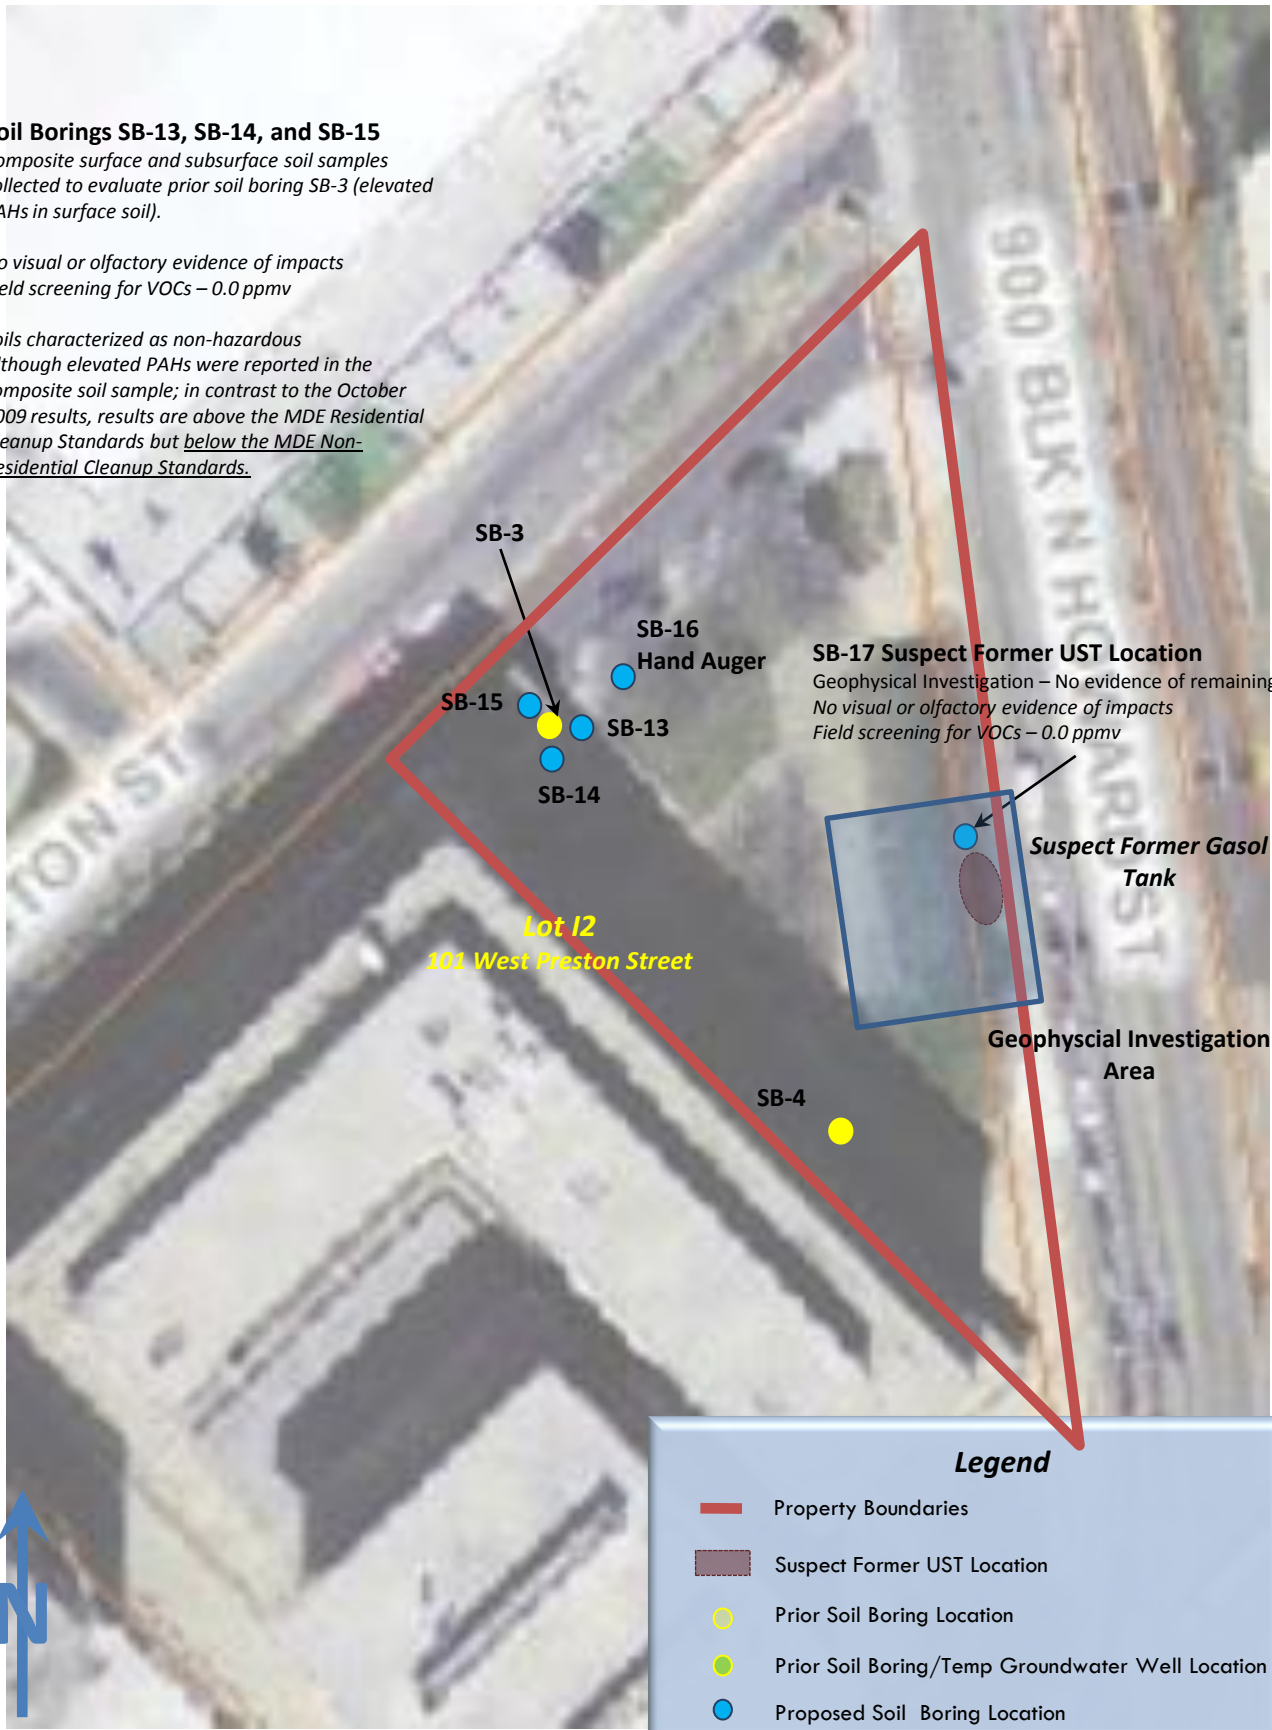
No visual or olfactory evidence of impacts  
Field screening for VOCs – 0.0 ppmv

Soils characterized as non-hazardous  
Although elevated PAHs were reported in the composite soil sample; in contrast to the October 2009 results, results are above the MDE Residential Cleanup Standards but below the MDE Non-Residential Cleanup Standards.

**SB-17 Suspect Former UST Location**  
Geophysical Investigation – No evidence of remaining UST  
No visual or olfactory evidence of impacts  
Field screening for VOCs – 0.0 ppmv

**Suspect Former Gasol Tank**

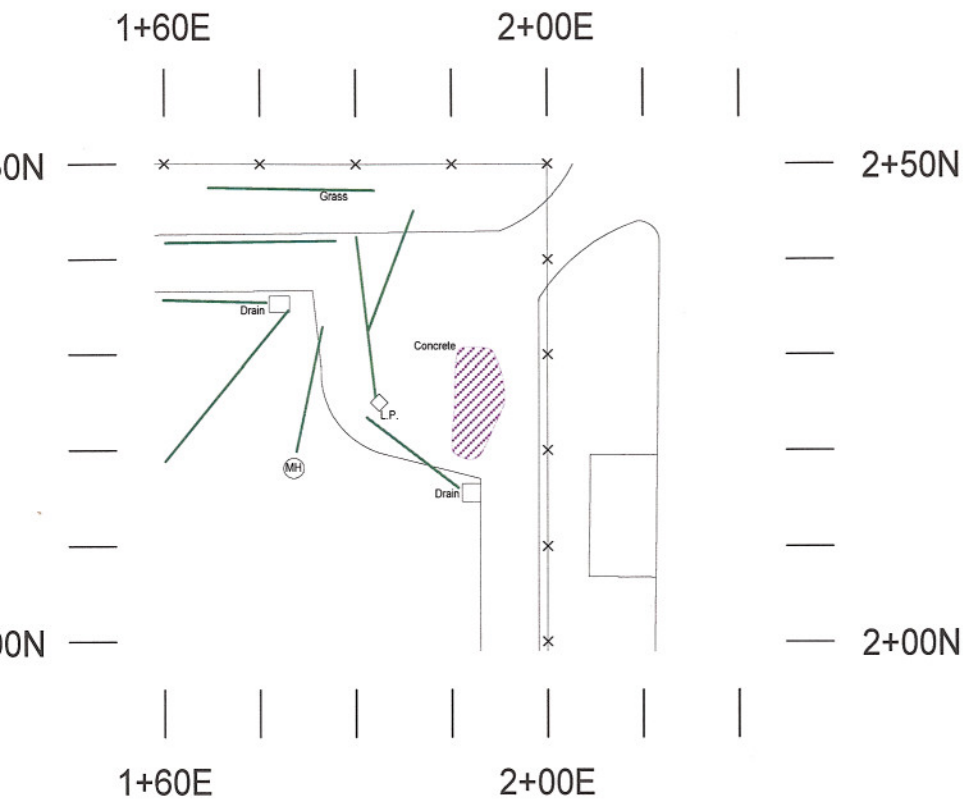
FIGURE 3  
 INTERPRETATION, AREA 1  
 State Center Property Parcels  
 Baltimore, MD  
 prepared for  
 Urban Green Environmental, LLC.  
 Baltimore, MD  
 July 2010

The anomalous area was detected at approximately 2+19N to 2+31N, 1+90E to 1+96E. The cause of this area is unknown but may be a possible pipe or foundation. Figure 3 shows the location of this area.

Figures 3, 8, 13, and 18 show the locations of all areas and objects detected by the geophysical survey.

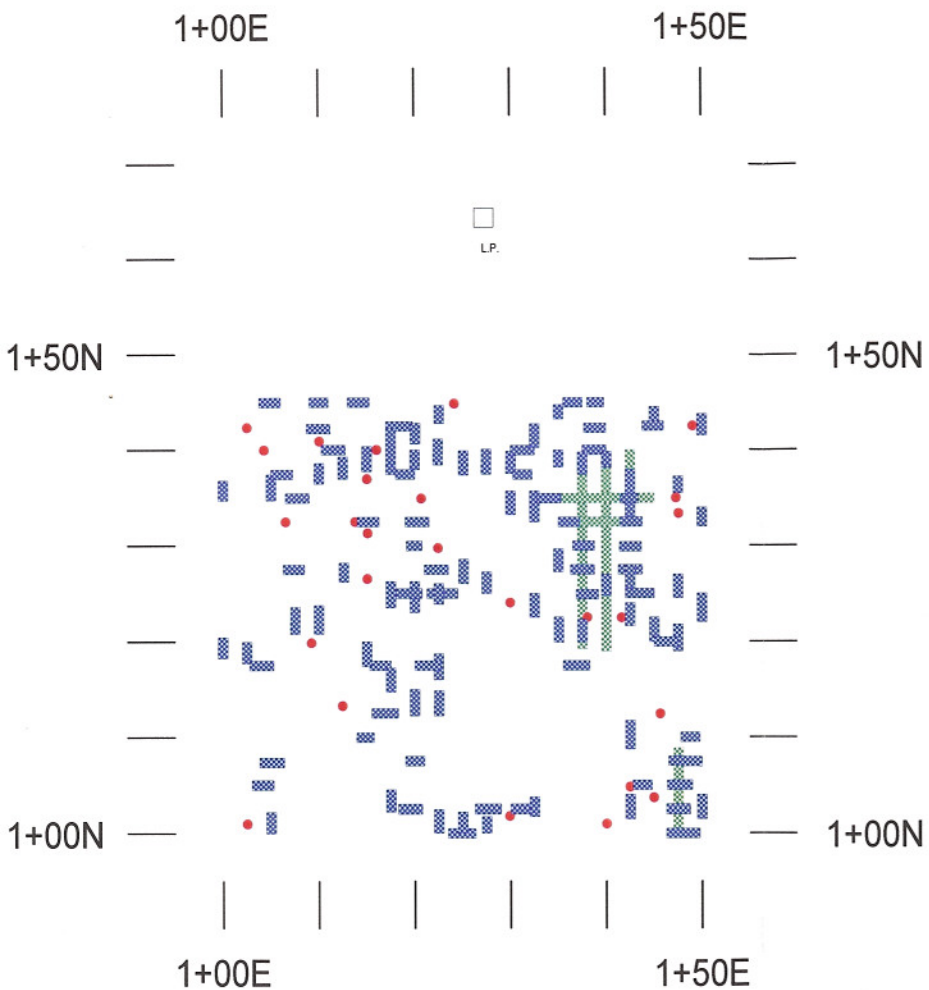
**FIGURE 12**  
**GPR ANOMALY MAP, AREA 3**  
 State Center Property Parcel  
 Baltimore, MD  
 prepared for  
 Urban Green Environmental, LLC.  
 Baltimore, MD  
 July 2010

- Point target  
( Pipe, brick, cobble, metal, etc. )
- Larger GPR reflector
- Possible subsurface layer

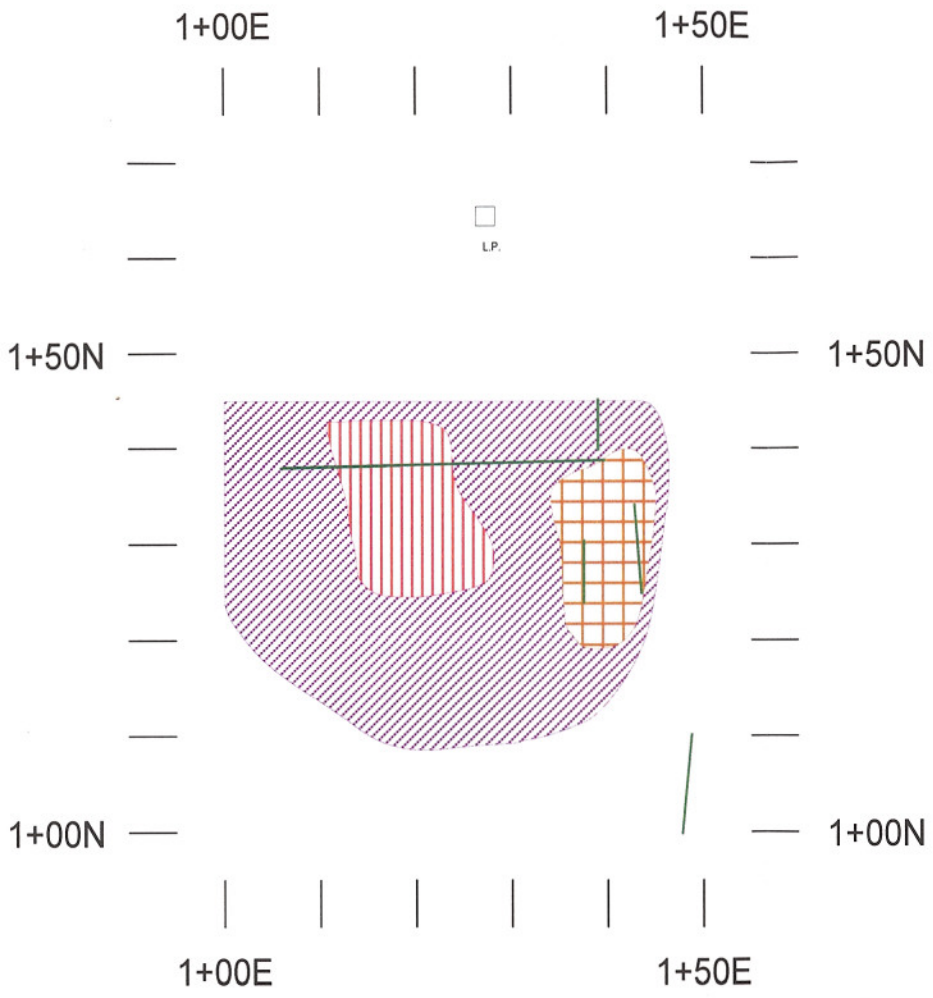
**FIGURE 13**  
**INTERPRETATION, AREA 3**  
 State Center Property Parcel  
 Baltimore, MD  
 prepared for  
 Urban Green Environmental, LLC.  
 Baltimore, MD  
 July 2010

An area of disturbed conductivity was detected by the survey at approximately 1+09N to 1+45N, 1+00E to 1+47E. This may be caused by a demolished building. See Figure 13 for the location of this area.

A possible subsurface layer was detected at approximately 1+19N to 1+40N, 1+34E to 1+45E. This may be caused by a buried slab or pavement. Figure 13 shows the location of this area.

An area of disturbed conductivity was in Area 3. This may be caused by a demolished building.

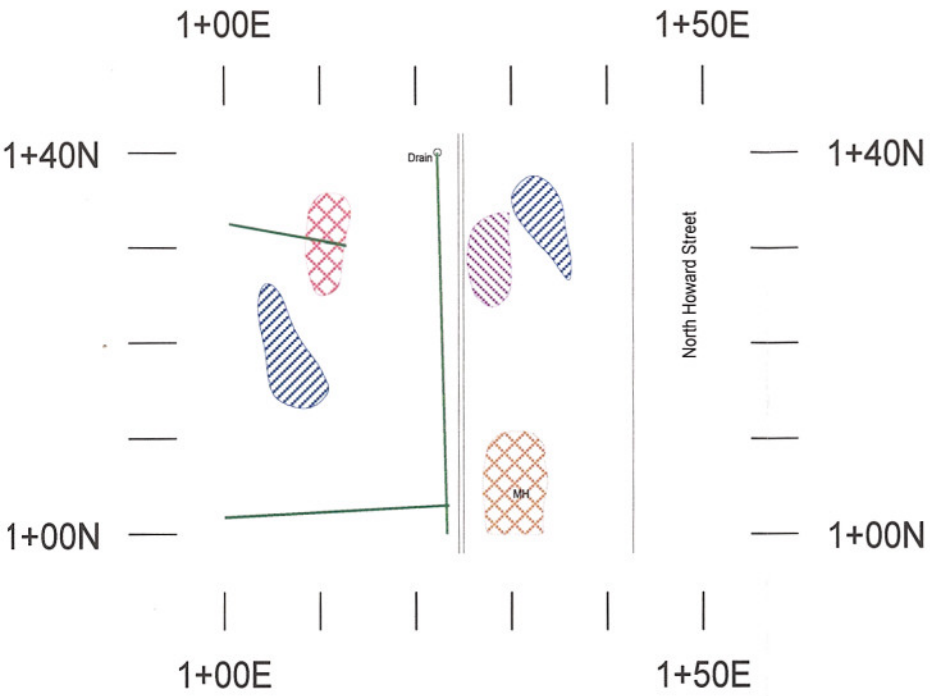
**FIGURE 18**  
**INTERPRETATION, AREA 4**  
 State Center Property Parcel  
 Baltimore, MD  
 prepared for  
 Urban Green Environmental, LLC.  
 Baltimore, MD  
 July 2010

The anomalous area was detected by the survey at approximately 1+24N to 1+34N, 1+25E to 1+30E. The cause of this area is unknown. Figure 18 shows the location of this area.

A magnetic high was detected at approximately 1+25N to 1+36N, 1+09E to 1+13E. The cause of this area is unknown but may be cultural interference. Figure 18 shows the location of this area.

The causes of these areas are unknown but could be cultural interference. Figure 18 shows the locations of these areas.

A magnetic high was detected in Area 2 and Area 4. The causes of the magnetic high in Area 4 may be cultural interference. Further investigation of both may be considered to determine the cause of each.

Two magnetic lows were detected in Area 4. These areas may be caused by cultural interference.
